2.1

PEORIA EXISTING CONDITIONS

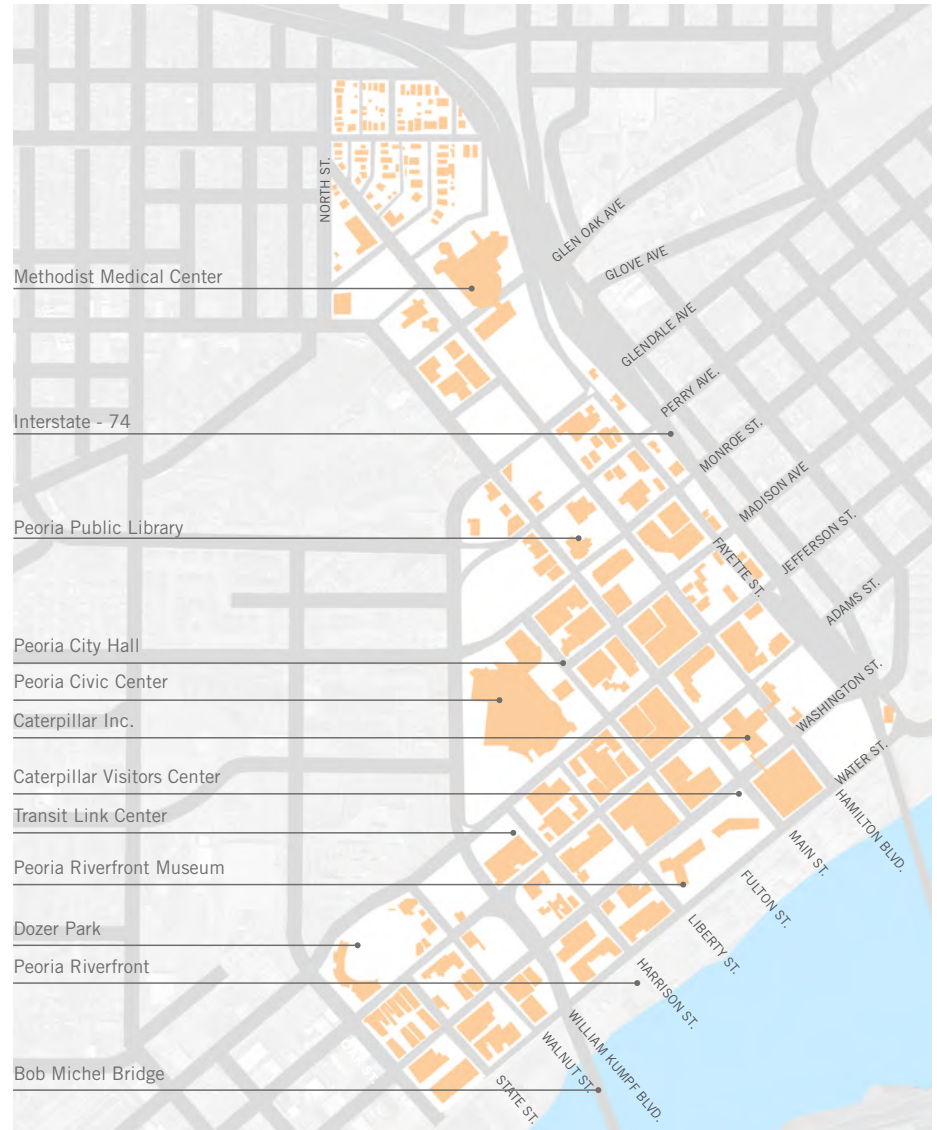
Peoria Existing Condition Plan

Street sections were prepared for each alignment to illustrate the proportion of the storefront zone, pedestrian zone, amenity zone, parking condition, lane widths and median widths. This documentation established a baseline for contrasting the existing with proposed street typologies.
